## 18000 Pump Series Technical Guide

# Assembly / Disassembly Instructions

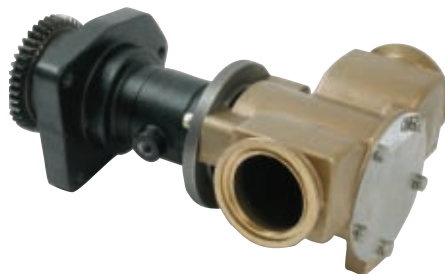
**G1808, G18081-01, G18082-01\*  
and G18082X\***

\*G18082-01 and G18082X do not have the oil tap shown in the pump bearing body.

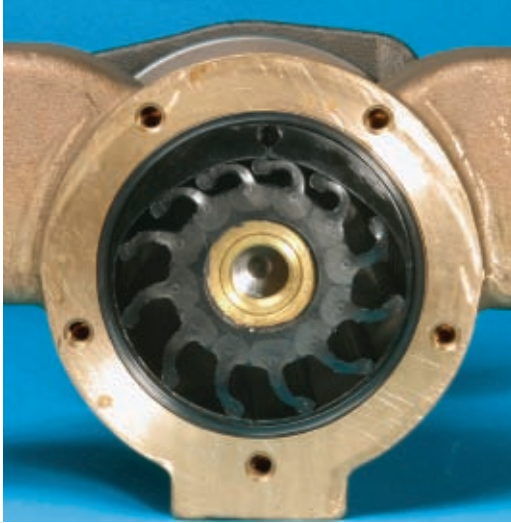
Vanes flipped to the left  
(viewed from cover).

**Models:** G1808, G18081-01, G1810, G1810-01,  
G1814-01, G18082, G1814X, G1811-01 and G1816-01
